2.0 Edgemont, South Dakota, Disposal Site

2.1 Compliance Summary

The Edgemont, South Dakota, Uranium Mill Tailings Radiation Control Act (UMTRCA) Title II Disposal Site was inspected on June 12, 2007, and was in excellent condition. The entrance signpost was broken, and the sign was relocated to the entrance gate. The site continues to be grazed by a local rancher in exchange for checking site security and repairing the perimeter fence. Noxious weeds persist on and adjacent to rock-covered surfaces and will require continued monitoring and control. Groundwater monitoring is not required at this site. No cause for a follow-up inspection was identified.

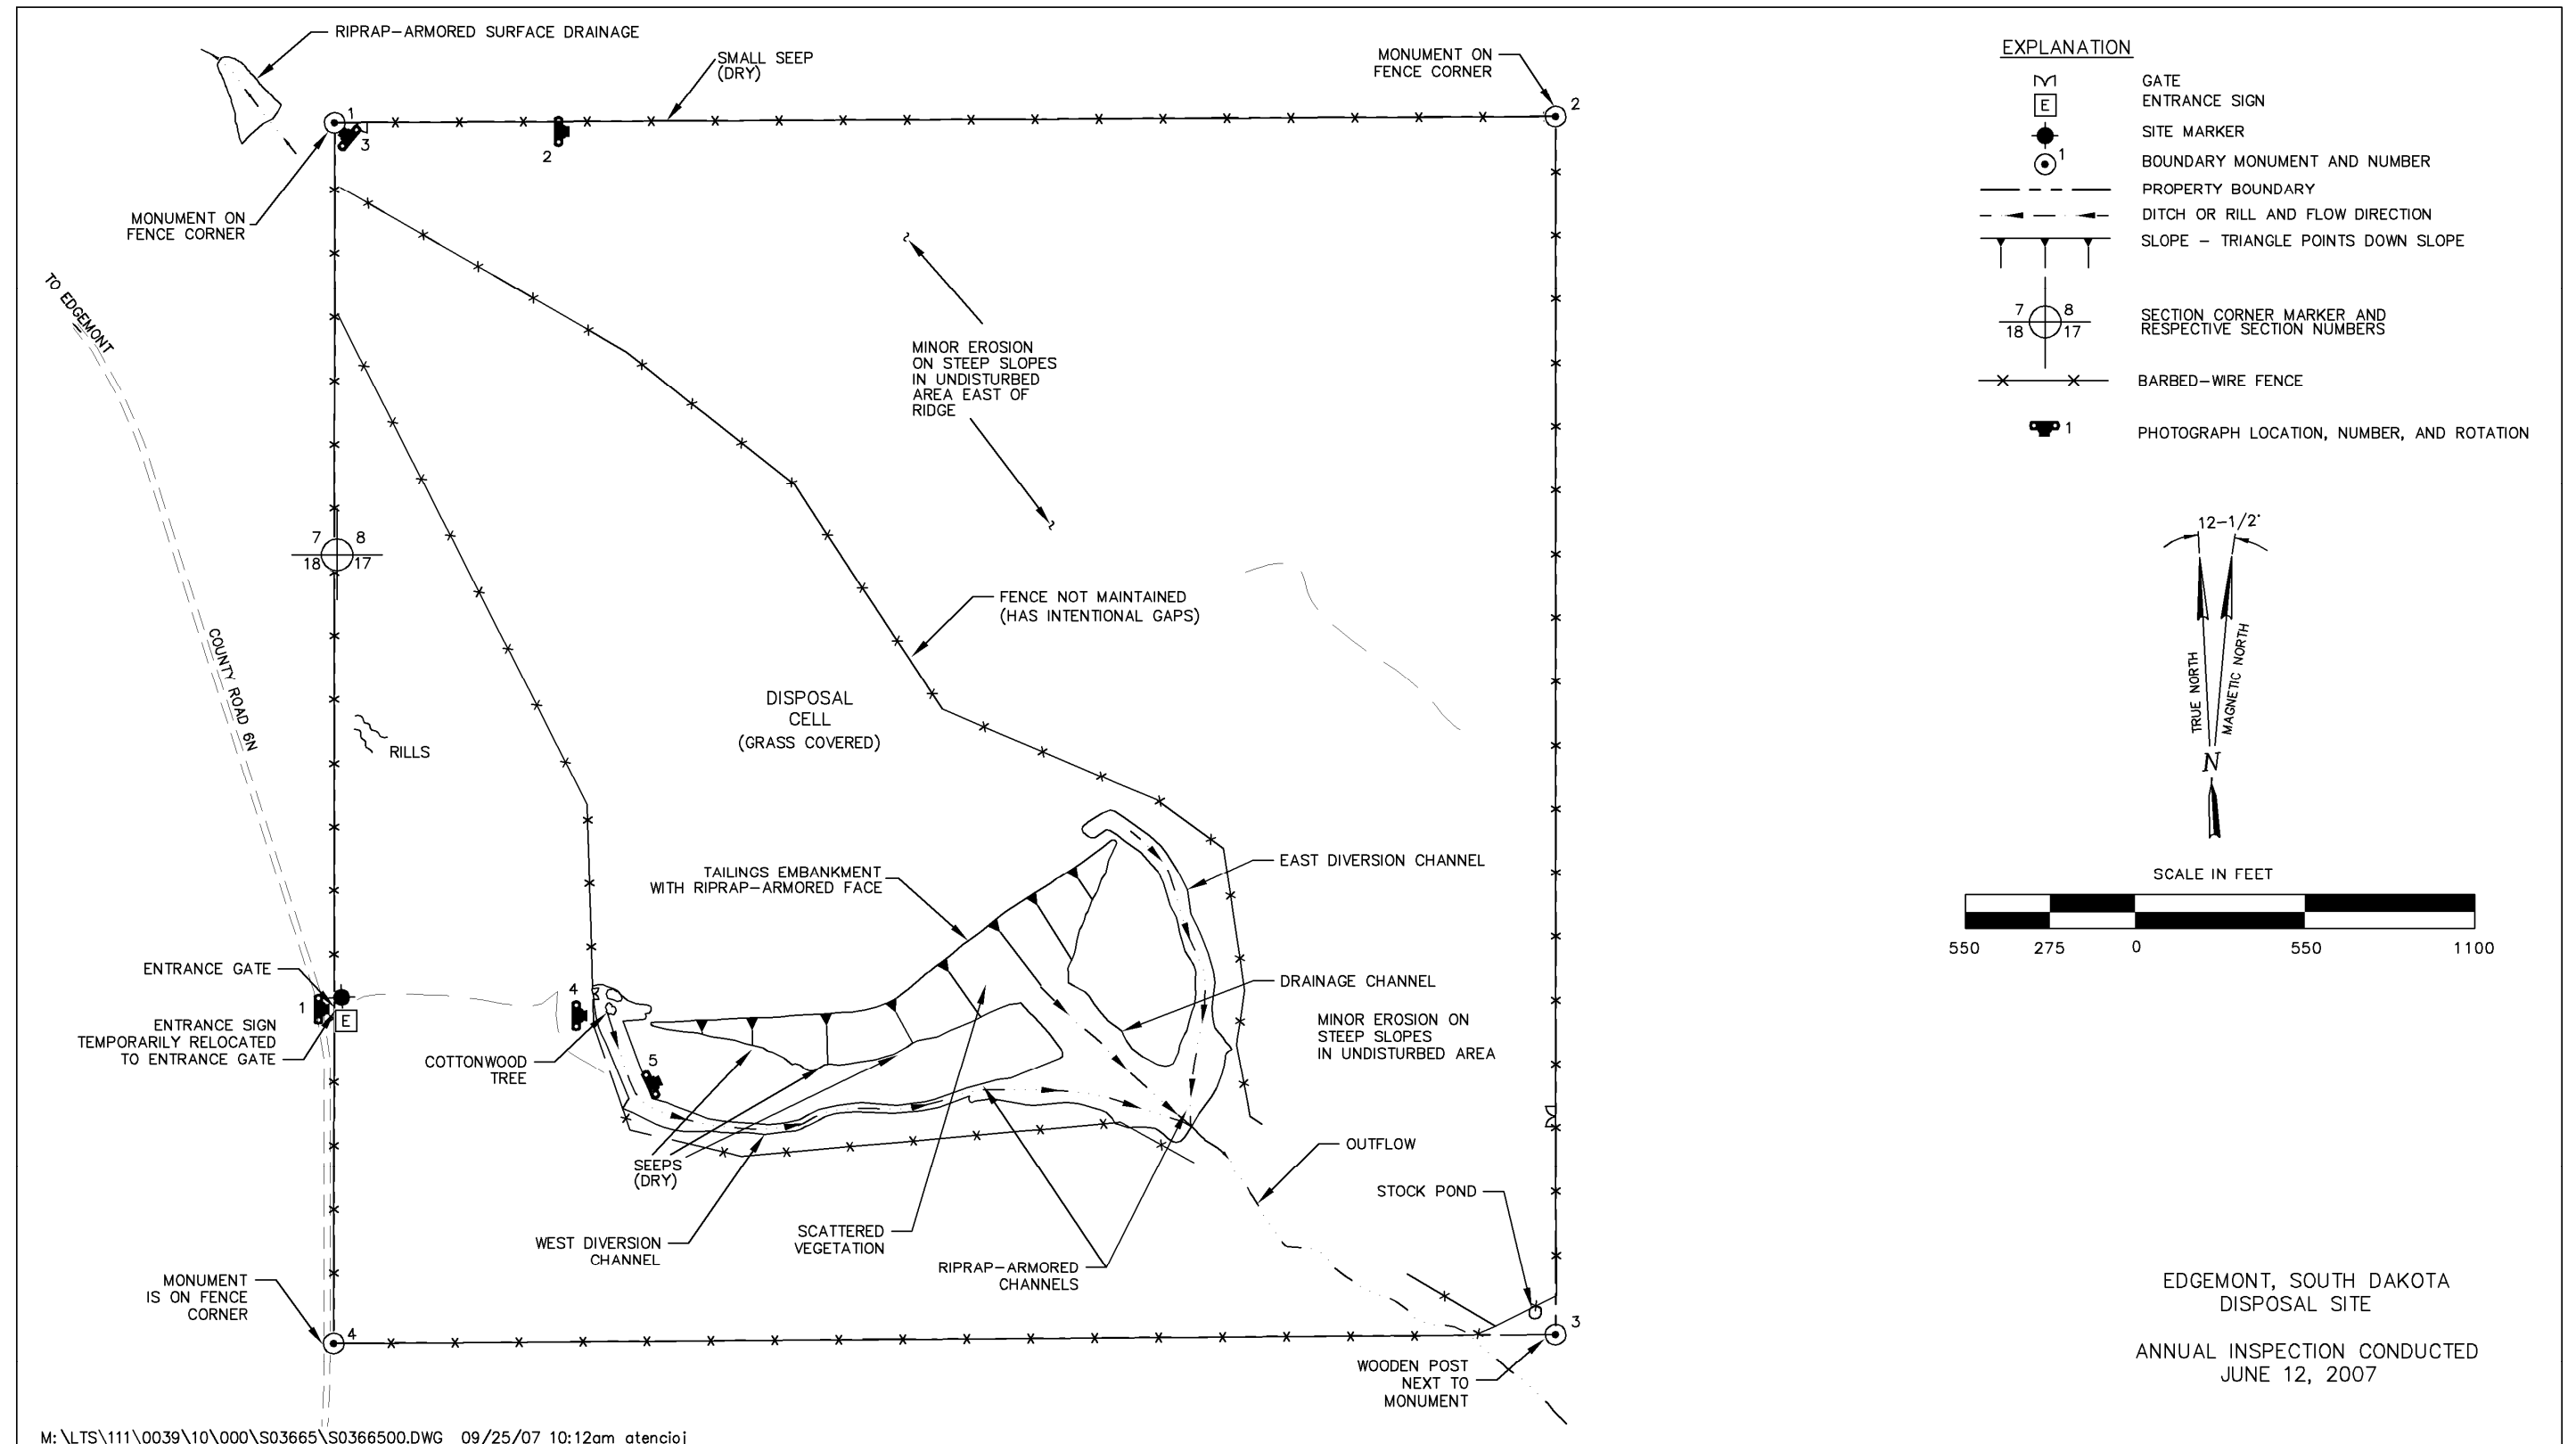
Figure 2-1. 2007 Annual Compliance Drawing for the Edgemont, South Dakota, Disposal Site

2A The entrance sign was the only warning/no trespassing sign installed at the site. At the time of the inspection, the signpost was broken and laying on the ground; the damage likely was caused by cattle. The sign was relocated to the entrance gate (PL-1), and will be moved to a new post inside the gate in 2008.

Site Marker and Monuments—One unpolished granite site marker identifying the disposal site is located just inside the entrance gate and was in excellent condition. Four boundary monuments, located at each corner of the property, were in excellent condition (PL-3).

Top of the Disposal Cell—The 100-acre top of the disposal cell, completed in 1989, is grass-covered and was in excellent condition (PL-4). DOE manages the grass cover through controlled grazing. The grass is well established and was not overgrazed when inspected. Numerous cattle trails are present on the cell top, but there were no indications of erosion, settlement, or other modifying processes that might affect the integrity of the cell.

Embankment Face and Drainage and Diversion Channels—The embankment face, the steepest man-made slope on site, is covered with riprap. The slope is stable, and the riprap showed no signs of degradation. Scattered plants, mostly grass and annual weeds, grow in the riprap (PL-5). These plants do not pose a threat to the stability or function of the embankment face.

2B DOE has retained the Fall River County weed control agent to spray Canada thistle, a noxious weed persisting on the site, since 1998. The thistle usually has been found growing on and along the edges of the riprap-armored surfaces. Numerous patches were present at the time of the inspection. These patches subsequently were sprayed with herbicide by the county.
